Report on Excavation for the Dulverton Weir Project 2022
by Nigel Dymond (NDAS)

Trench 3 (1m x 1m)

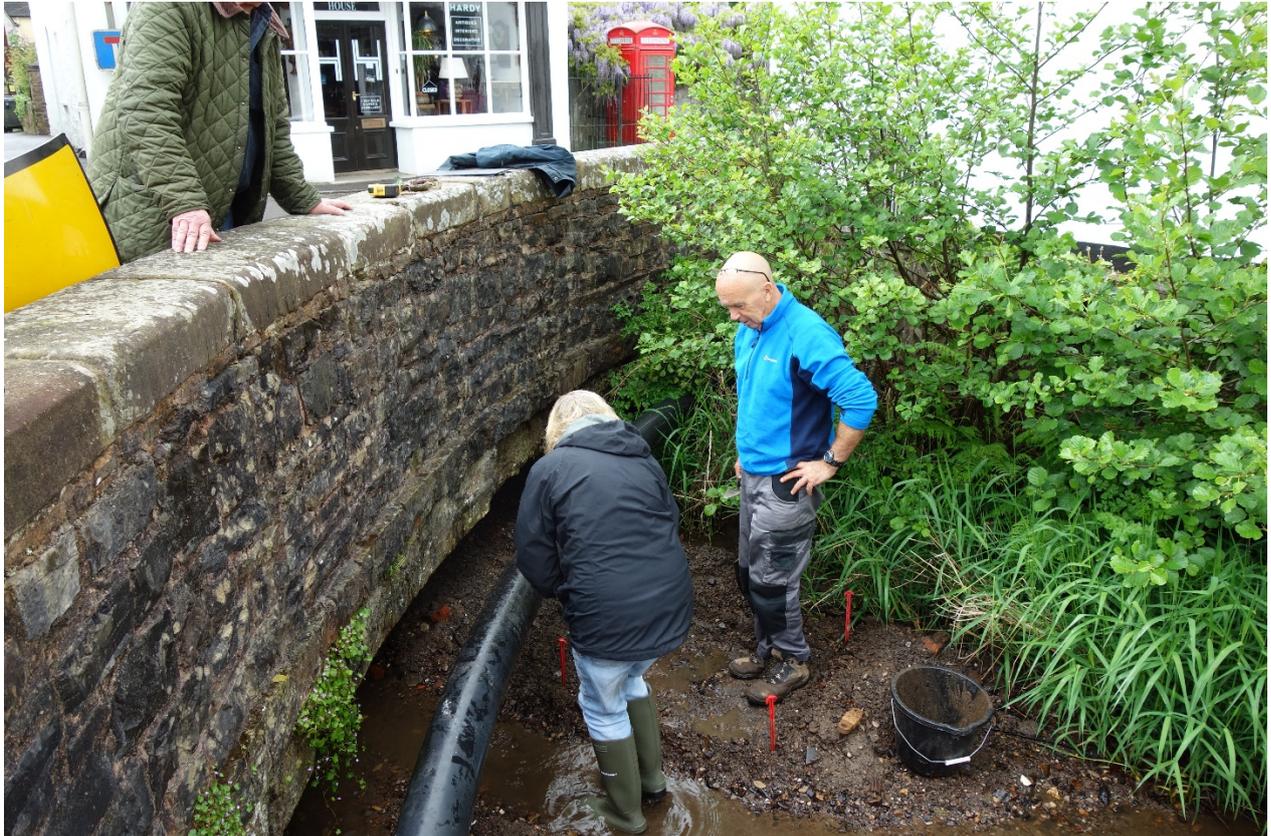
Figure 2 – Marking out the trench.

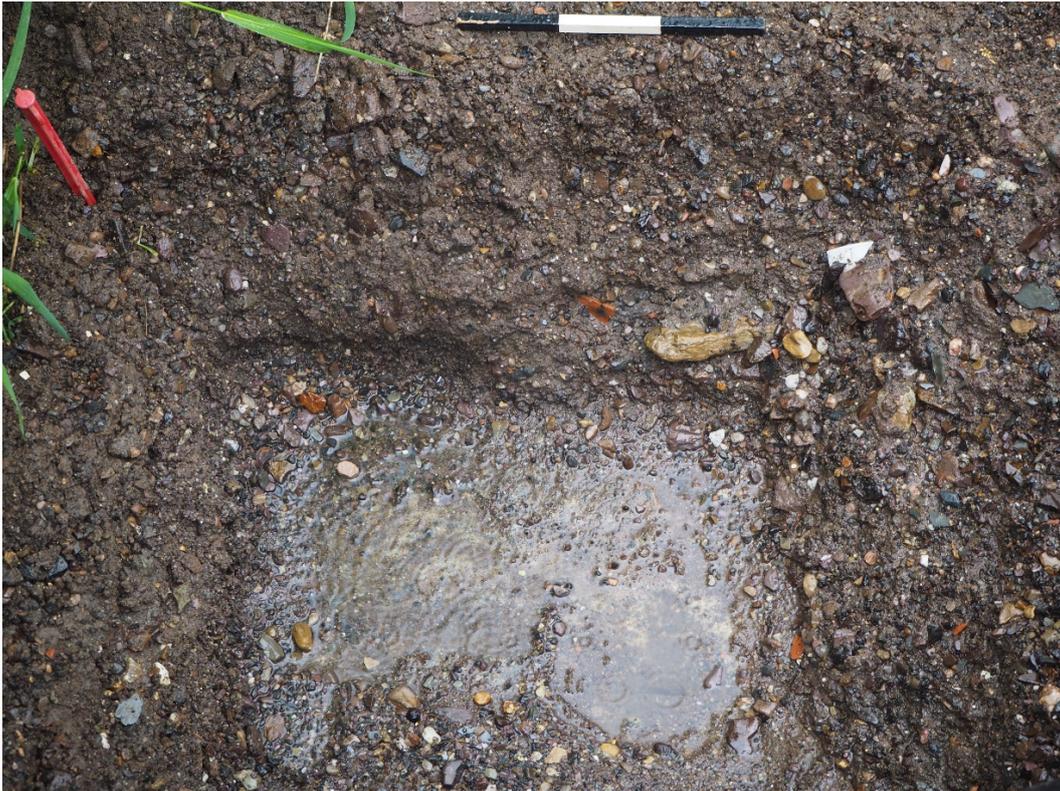
Figure 3 – Showing the floor of the leat. Scale = 30cm

The top layer (300) of the deposits over the leat floor comprised of small pieces of natural gravel and small stones – brown, black and white. Beneath this was (301), a layer of more compact mid brown/grey silted clay, containing water borne pebbles 1cm to 5cm. Finds included coins (all decimal), broken glass (mainly broken bottles), a piece of ‘Bridgewater’ roofing tile, sherds of pottery, ceramic beads from a modern bracelet/necklace (Fig. 7) and part of a brick (manufactured). Beneath this was (302) a reddish-brown silt layer which still contained modern finds: decimal coins, broken bottle glass and ceramic beads. Beneath this was (303) the lime mortar base (with stone inclusions) of the leat. The base had been covered by approximately 30cm of silt (Fig 3).

The lime mortared base of the leat at this location was something of a surprise. Previous reports had suggested it was cobbled, although this may have been a description of the stone inclusions in the mortar. The lime mortar suggests a later resurfacing of the leat base and in general, its use in Devon suggests a post-medieval date.

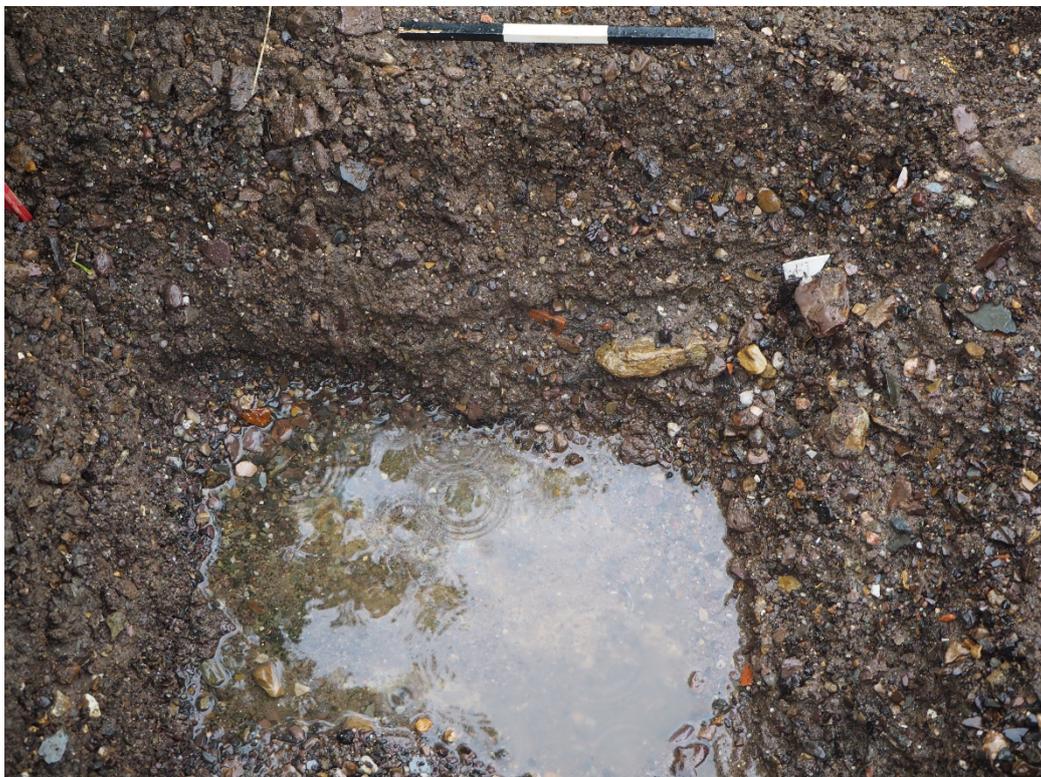
Figure 4 – This photo was taken approximately 30 seconds after the one above (Fig 3) and illustrates the rate that water was ingressing into the trench.

The flow of the leat was reduced and Phillip Hull constructed a small cofferdam around the area to be excavated. Whilst the amount of water entering the area of Trench 3 was greatly reduced, it proved impossible to prevent the ingress of water into the trench.
